AN INSIGHT INTO CATHODIC PROTECTION SYSTEMS FOR REINFORCED CONCRETE STRUCTURE

Miki Funahashi, P.E.
MUI International
www.mui-int.com

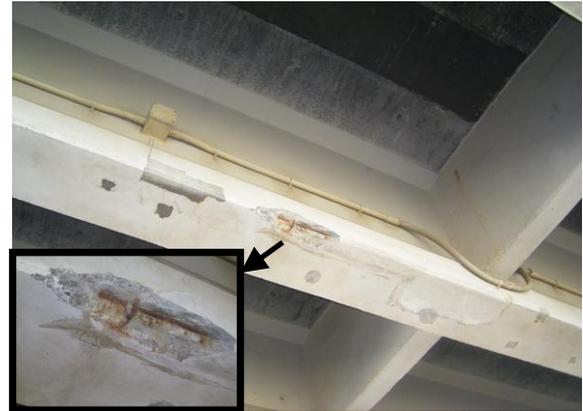
Figure 2. Concrete spalls after the discrete anode CP system was installed.

Figure 1 shows the example of wrong application of discrete anodes to the prestressed concrete beams which were exposed to a marine atmosphere. The reinforcing steel in the lower portion of the beams were experiencing corrosion. To reduce the cost of the CP system, the designer installed only two discrete anodes from the top portion of the beam. However, the beam contains many steel components, including rebars, post-tensioned ducts. One of the advantages of discrete anodes is good current distribution when the anode is located in a proper position in the concrete component. However, the position of the discrete anodes was wrong because the internal steel components were too close to the anodes. Figure 2 shows the results of the CP performance after 3 years. To prove the ineffectiveness of the CP system, the current distribution from the anode to the surrounding steel components was analyzed using the finite element method, as shown in Figure 3.

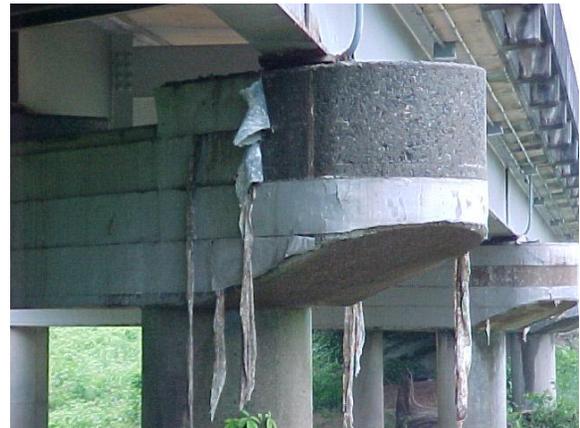
Figure 4. Zinc anode failure

The durability of the anode is the most important cost factor. Even though the CP system is initially effective, premature failure of the anode, if occurs, will cost additional money to the owner to maintain the structure. Figure 4 shows an example of the premature failure of the zinc anode.

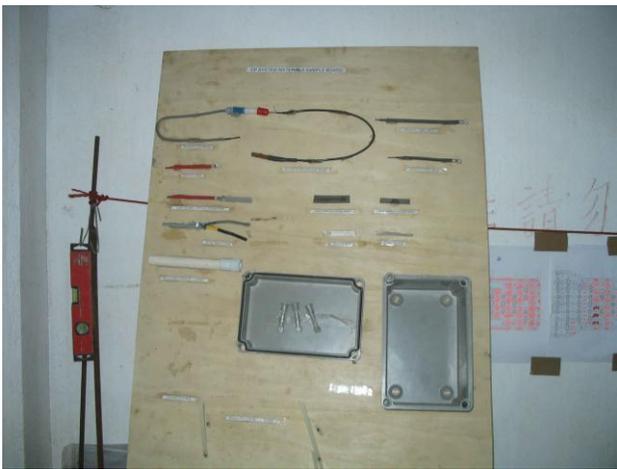
Figure 7. Identifications of all CP components For training inexperienced works at a job site

Since CP becomes more popular to rehabilitate corroding concrete structures, many new contractors are involved in the installation. However, inexperienced CP contractors are not familiar with the detailed works involving the CP system installation and required testing. As a result, the system may not function properly, or the durability of the system may be compromised. To overcome this problem, some contractor includes training program to their workers. Figure 7 shows some examples that by identifying various CP parts to their inexperienced workers, the contractor tries to minimize mistakes.

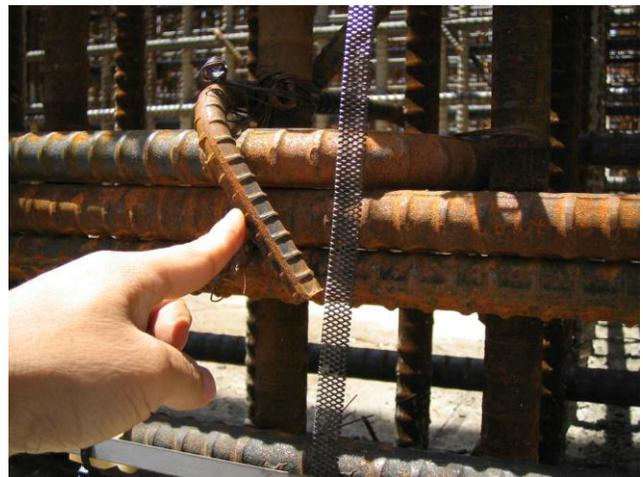
Figure 8. The possible cause of near short circuit

Another important factor for CP systems to properly function is the current distribution to the steel embedded in concrete. Uneven CP current distribution is caused by a high voltage-drop in the anode system and/or near-short circuits between the anode and the reinforcing steel. Many CP engineers are reasonably familiar with the voltage-drop and short circuit. However, the near-short circuit is more common to cause a problem to a CP system. The definition of the near short circuit is somehow difficult because the level of problem by the near short circuit varies for type of anode, the circuit resistance of the anodic zone, location of the near circuit, etc. Near-short circuit is the concentration of the CP current discharge at local area(s) of the anode system to the embedded steel. The condition of each near-short circuit is different, and in some cases it is detrimental to the CP system performance. Figure 8 shows an example. Since the detection of near-short circuits is difficult during the CP system installation, many CP engineers cannot find out until the system is commissioned.

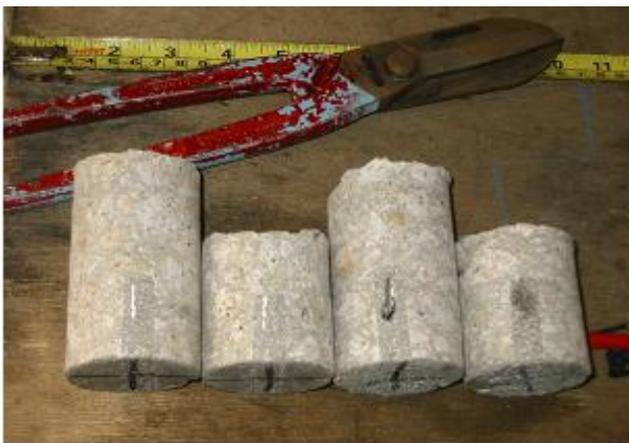
Figure 9. Grouting conditions inspecting by cores

When a slotted CP system is designed and installed, the slots must be filled with cementitious grout material. Since the slots are deep and narrow, the filling method of the grout is important. After the grouting operation is completed, concrete cores must be taken to inspect the grout filling condition in the slots as shown in Figure 9. Figure 10 shows the poor grouting conditions. When approximately a half of the titanium ribbon mesh anode is not embedded in the cementitious material, this causes much higher anode current density discharging from the anode, and it may result in acid generation at the anode/concrete interface. If so, the anodes where are not completely encapsulated may fail in a short period of time.

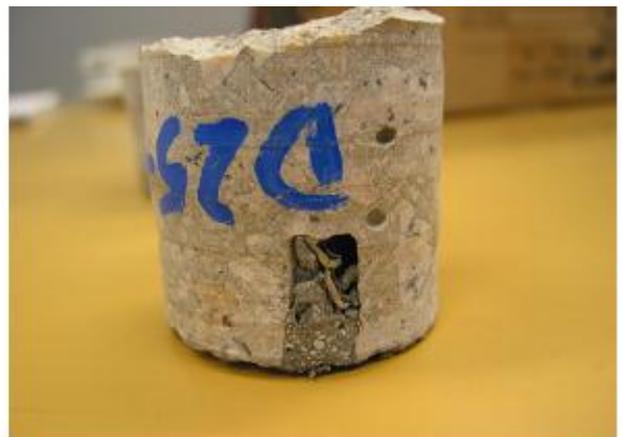
Figure 10. Poor grouting condition in slot
